# **D2.1 - Specifications for the online damage monitoring systems**

## **WP2 - Task 2.1 October 2025**

| Project Acronym | FIND |
| Project Name | Future Instrumentation and coNtrol based on innovative methods and Disruptive technologies for higher safety level |

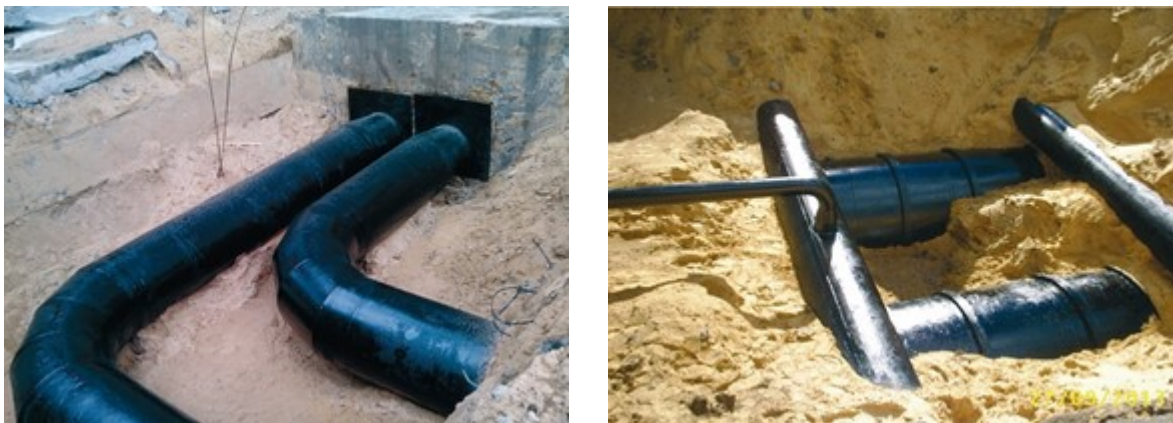
**Figure 1-1: ESWS pipes (after excavation) (ref. to National Report: First Topical Peer Review Ageing Management. State Nuclear Regulatory Inspectorate of Ukraine. Kyiv 2017  
[www.ensreg.eu/sites/default/files/attachments/ukraine.pdf](http://www.ensreg.eu/sites/default/files/attachments/ukraine.pdf)**

Concealed pipes may belong to safety-related systems. A typical example in WWER and Western PWR designs is the Essential Service Water System (ESWS), which supplies cooling water to the spent fuel pool and safety-related equipment (Figure 1-1). Such pipes operate at low or even atmospheric pressure. They may only be partially filled by water in some sections, the rest of the volume being occupied by air. In this case, condensation can form on the upper inner wall of the pipe.

The ESWS includes multiple concealed pipe sections: in/out pipes between the heat sink (sea or river) and the reactor building, spray pond in/out pipes, and distribution lines. These pipes are buried underground at depths of up to 6 meters. The bedding and backfill consist of loose, damp sand with varying density. Figure 1-1 shows pipe examples after excavation. This system must adapt to the local topology of the site, so it is less standardized than other NPP systems. They have a long service lifetime, typically 30 years.

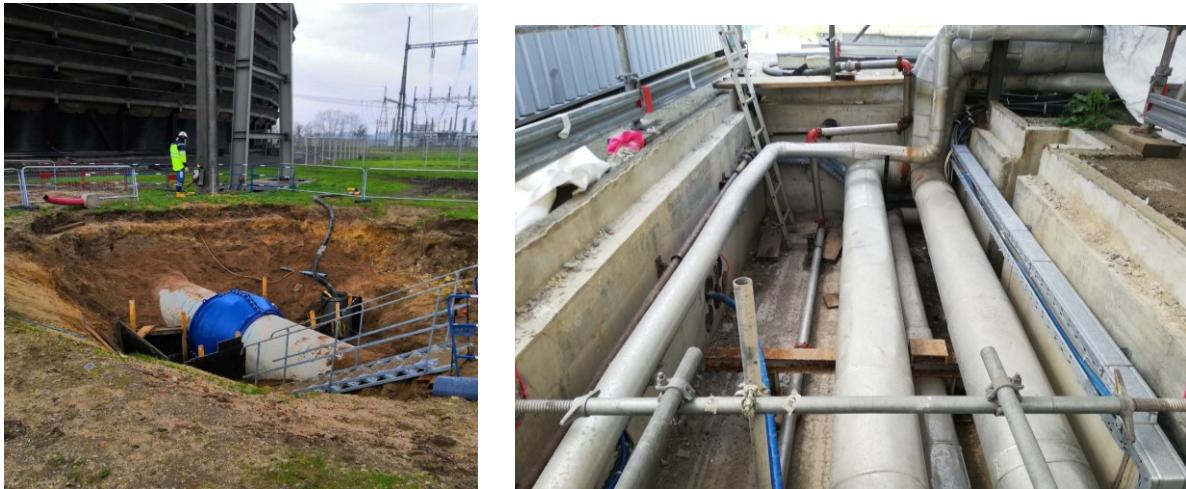
Figure 1-4: Service water pipes, buried or in galleries.

Figure 1-4 shows examples of a buried service water pipe and service water pipes in a gallery, both on French sites.

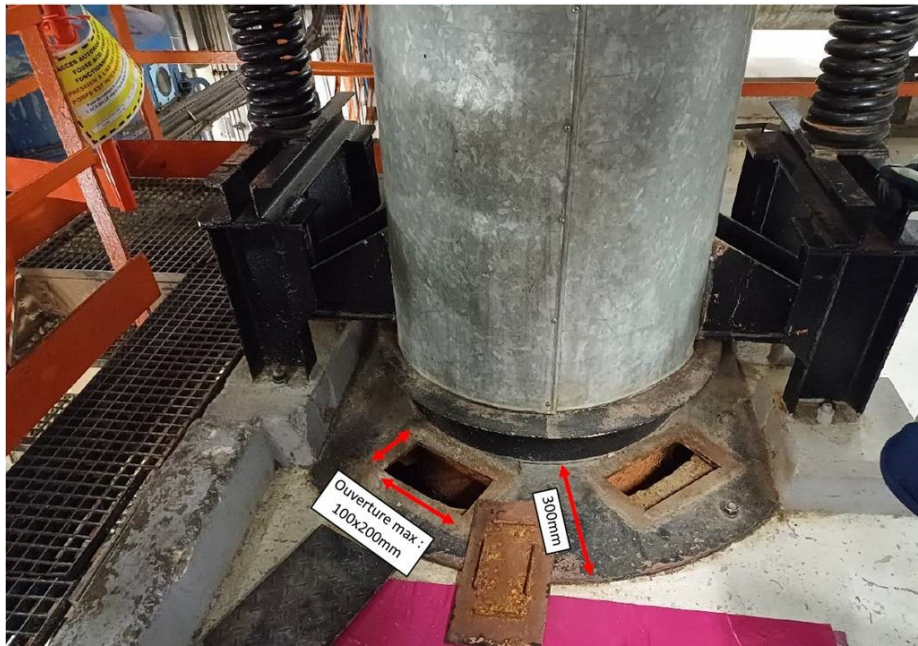
Figure 2-1: Preheater siphon in place with heat insulation.

The low-pressure preheater siphon is a 6200 mm long component with only the top section accessible for instrumentation, the bulk of the length (more than 5 m) being surrounded by concrete, with a thermal insulation between the siphon and the concrete structure. Siphons extracted and replaced in the Tricastin plant showed superficial corrosion in the lower section. A guided wave screening technique is sought to scan the inaccessible section for wall thickness loss due to corrosion. The picture below in Figure 2-1 shows the accessible section with the thermal insulation still in place; it would be removed for the installation of the instrumentation. The second figure in Figure 2-2 shows the actual geometry, including the inaccessible section surrounded by concrete. Figure 2-3 shows the schematic of EDF preheater siphon in place.

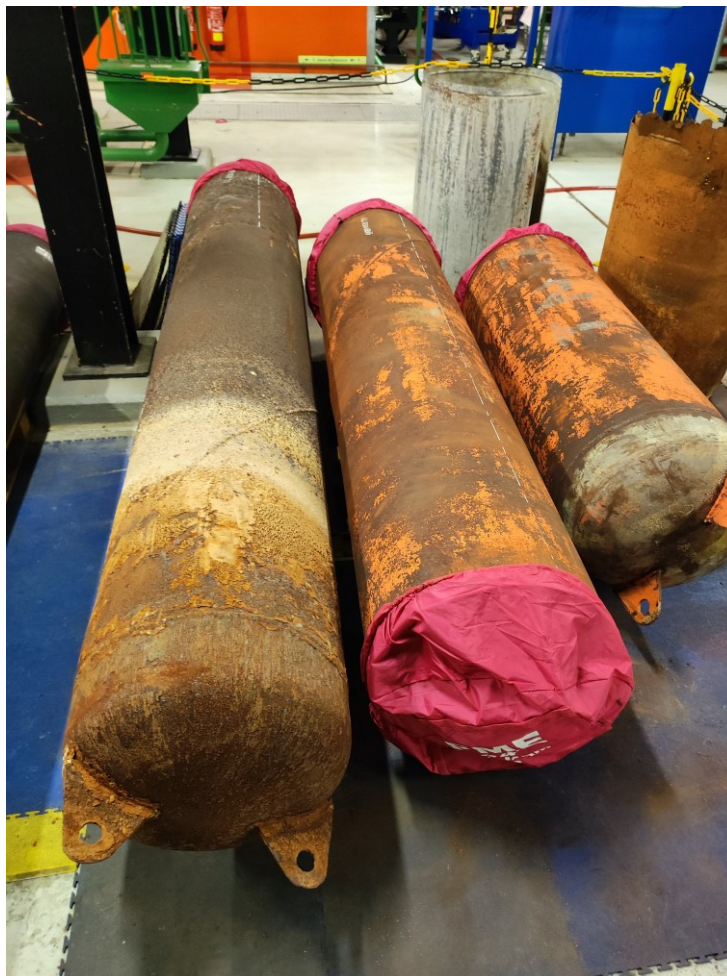
Figure 2-2: Extracted Preheater siphon (inner and outer tubing).

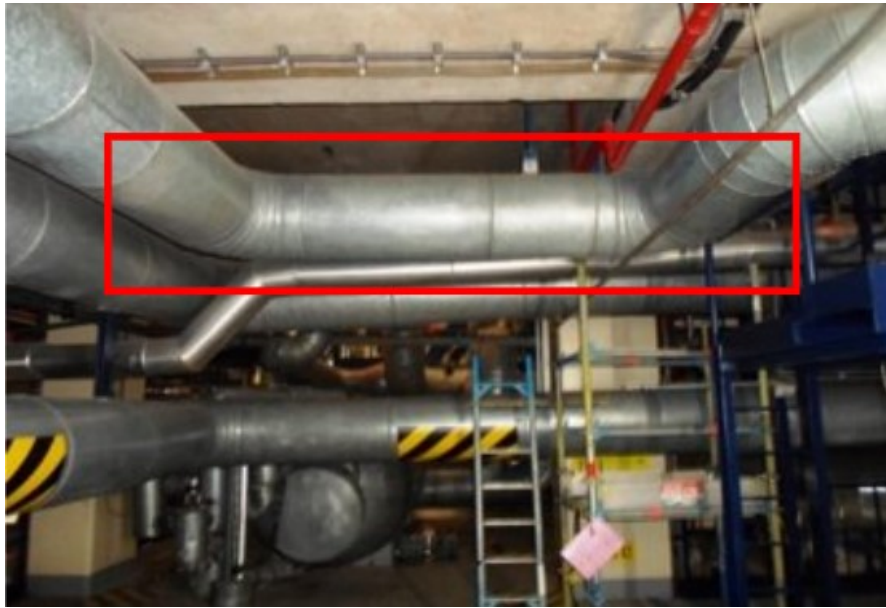
Figure 3-3: Images of the high-pressure steam turbine extraction line.

In Tihange 3, the high-pressure steam turbine extraction line, or more precisely, the line coming from the dryer/superheater to the superheater purge tank (see Figure 3-2 and Figure 3-3), has been identified as highly susceptible to FAC thanks to a predictive tool and inspection campaigns in 2015 and 2018 (UT) that revealed loss of thickness (up to 1.3 mm in elbow E6 and 2.19 mm in elbow E8 in 3 years). It is therefore proposed as a use-case for testing new sensors technologies developed in FIND.

| General information | | | |
|---|---|---|---|
| Component(s) concerned | High pressure steam turbine extraction line.<br>More precisely, the line coming from the dryer-superheater to superheater purge tank. See Figure 3-2 and Figure 3-3. | Degradation mechanism | Flow accelerated corrosion |
